NewGov - Newton, MA

HDC-22-264

Historic District Application

24 ROBIN DELL
 AUBURNDALE, MA 02466

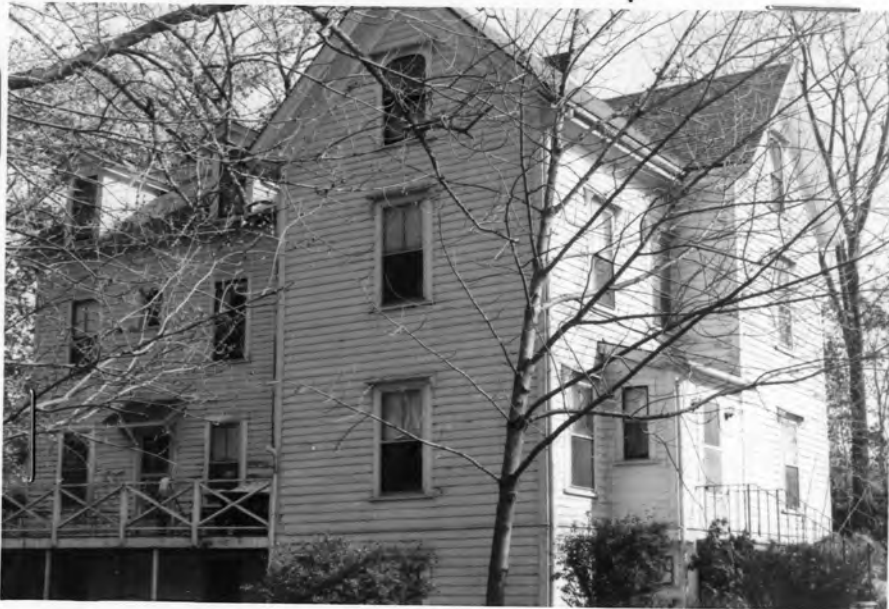
Auburndale
Address 113 Seminary Avenue
Present use residence
Present owner Lasell Junior College
Description: mid 1860's
Source surveyor
Style Italianate

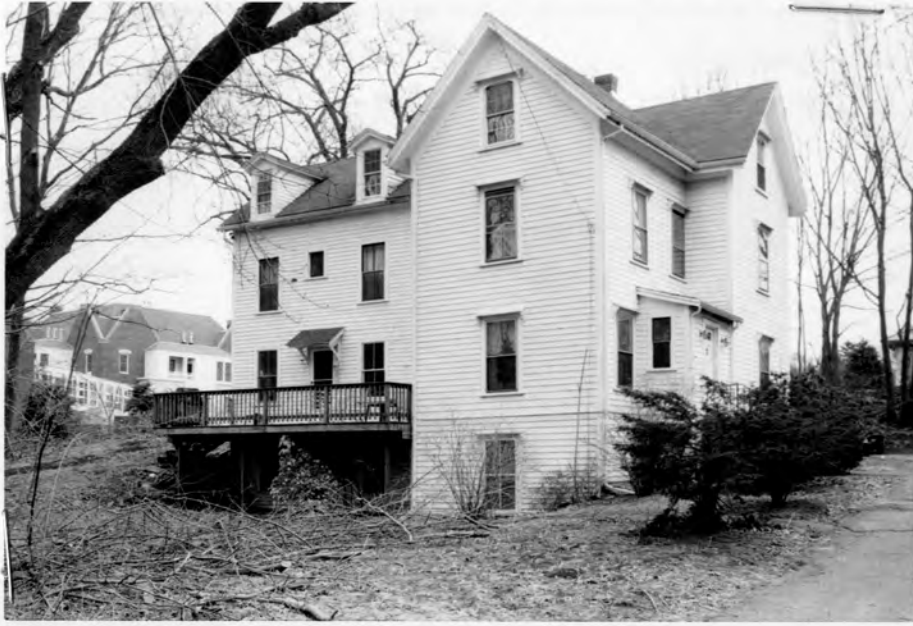
Photograph

Foundation: Fieldstone

Roof: Asphalt Shingle

Setting: This house is in a suburban neighborhood. It is at the end of a dirt/asphalt dead end street that is lined with fieldstone walls. From Grove Street, Robin Dell Street dips down at the mid-point, and then back up to this yard. The parking area is at the end of Robin Dell. The lot is in a natural wood setting. Mature trees surround the perimeter and there are flowering bushes at the foundation. Young pine trees also line the perimeter on a hill on the north and east sides providing a buffer from immediately adjacent Lasell Village.
